**Final Report
Salter's Grove
Causeway
Environmental and
Public Access
Improvements Project**

**PAWTUXET COVE
WARWICK, RHODE ISLAND**

Project No. R316-000.4

November 15, 2004

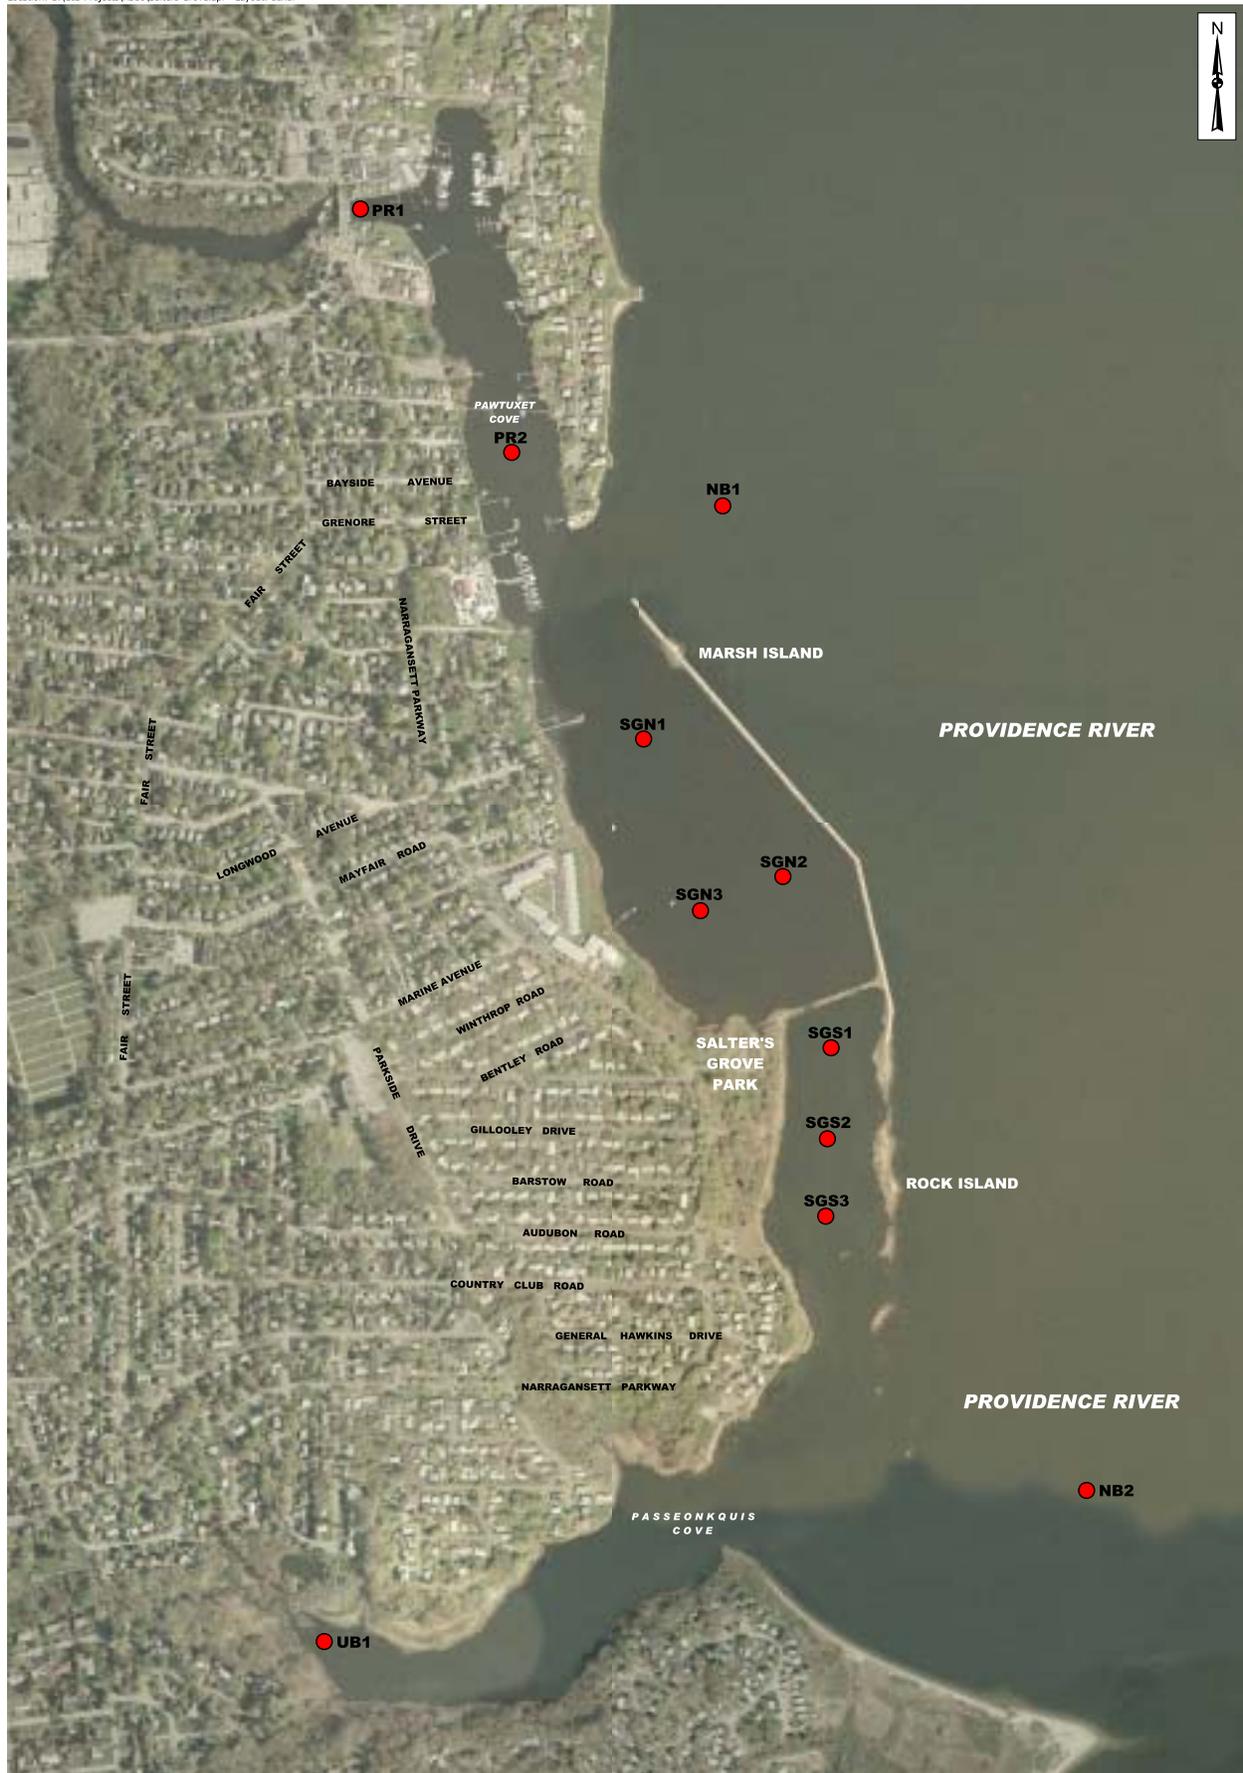
FIGURE 2

**Sample Collection Times
and Newport Predicted Tides**
August 2: Spring Low
August 3: Spring High

Two (2) sampling events were conducted during the summer months of 2004 on a spring tide (highest amplitude tide). Figure 2 illustrates the exact times and the relationship to Newport predicted tides (local Providence River area tides lag Newport tides by approximately 0.5 hours). The August 2 event was centered around low water. The August 3 event was scheduled around high water, but logistics caused the sampling to begin 2 hours late and therefore it coincided with early ebb. Wind conditions for both days were light and no heavy rain events (with accumulations of 0.5 inch) occurred immediately before (most recent rain event with greater than 0.5 inch accumulation occurred on July 28 – 0.66 inches).

As noted in Section 2.2, the high tide sampling event began about 2 hours after planned (Figure 2). This slight change of schedule meant that the "high tide" observations were actually collected during the early stages of the ebb tide. It was visually obvious that although the water level was very high (indicative of a spring high tide), there was significant water movement which suggests that it was not slack high (the tides in the upper bay are approximately standing waves and currents are at a minimum at high and low water). Some regions of the causeway were totally submerged (especially the region around the western culvert), and disturbances of the sea surface clearly suggested that there was water movement from the northern section of Salter's Grove (SGN) into the southern section (SGS).

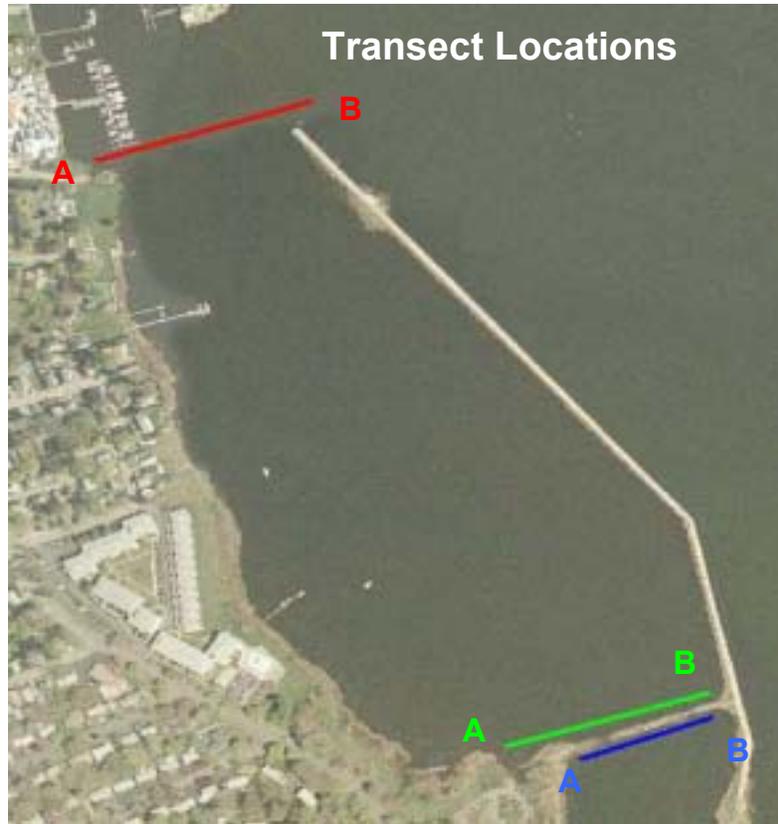
FIGURE 3

**Dissolved Oxygen Transects
Spring Tide, Early Ebb**

Figure 3a exhibits the location of the three dissolved oxygen transects. Figure 3b exhibits the results from the three dissolved oxygen transects. The x-axis represents an approximate relative location of the data. The primary feature of note is the minimum in both Transect 1 and Transect 2. This coincides spatially with the surface jet observed and the western culvert. In addition, the lowest dissolved oxygen values were observed to the west of Transect 3. Based on these three observations, it seems that low dissolved oxygen water is being transported from the Pawtuxet river along the western side of SGN and across the causeway at the western culvert. Note that water is only exchanged between SGN and SGS when the water level is very high. The eastern culvert also passes some water over the causeway, but not as much as the western; a minimum in dissolved oxygen is also coincident with the eastern culvert.
